**EXECUTIVE OFFICER'S REPORT** Covers March 1, 2023 – March 31, 2023

# 2. Early season treatment at Leviathan Mine, Alpine County – Leviathan Unit

#### 3. 2023 Stormflows along the Mighty Mojave River – Amanda Lopez and Anna Garcia

# 4. Impacts of heavy snow and rain events on South Tahoe Public Utility District's pump stations and recycled water reservoirs – *Tiffany Barulich*

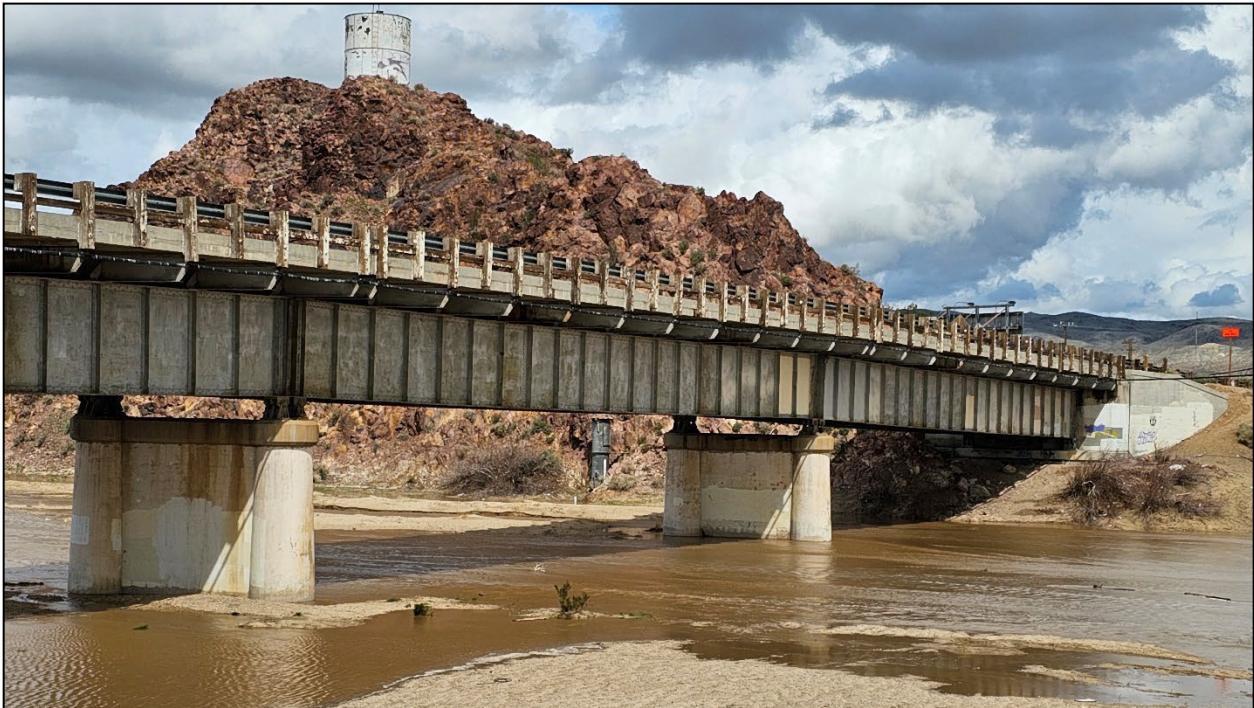
Figure 3.1 - Barstow First Street from east side of the First Street Bridge on 03/15/2023. USGS <u>Barstow stream gage</u> measured discharge is 133 cubic feet per second

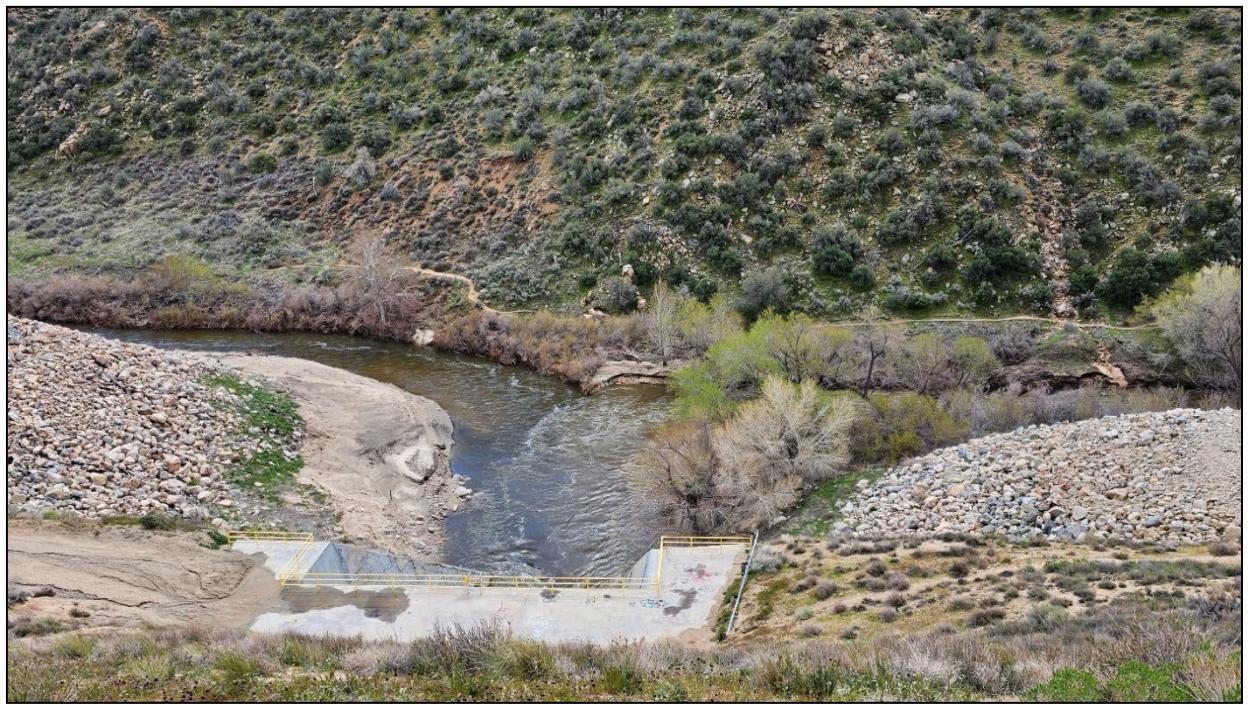
Figure 3.2 - Mojave River headwaters: Deep Creek on the left, West Fork on the right. View from top of Mojave Forks dam on 03/23/2023. USGS <u>Deep Creek stream gage</u> measured discharge 952 cubic feet per second and USGS <u>West Fork stream gage</u> measured discharge 481 cubic feet per second

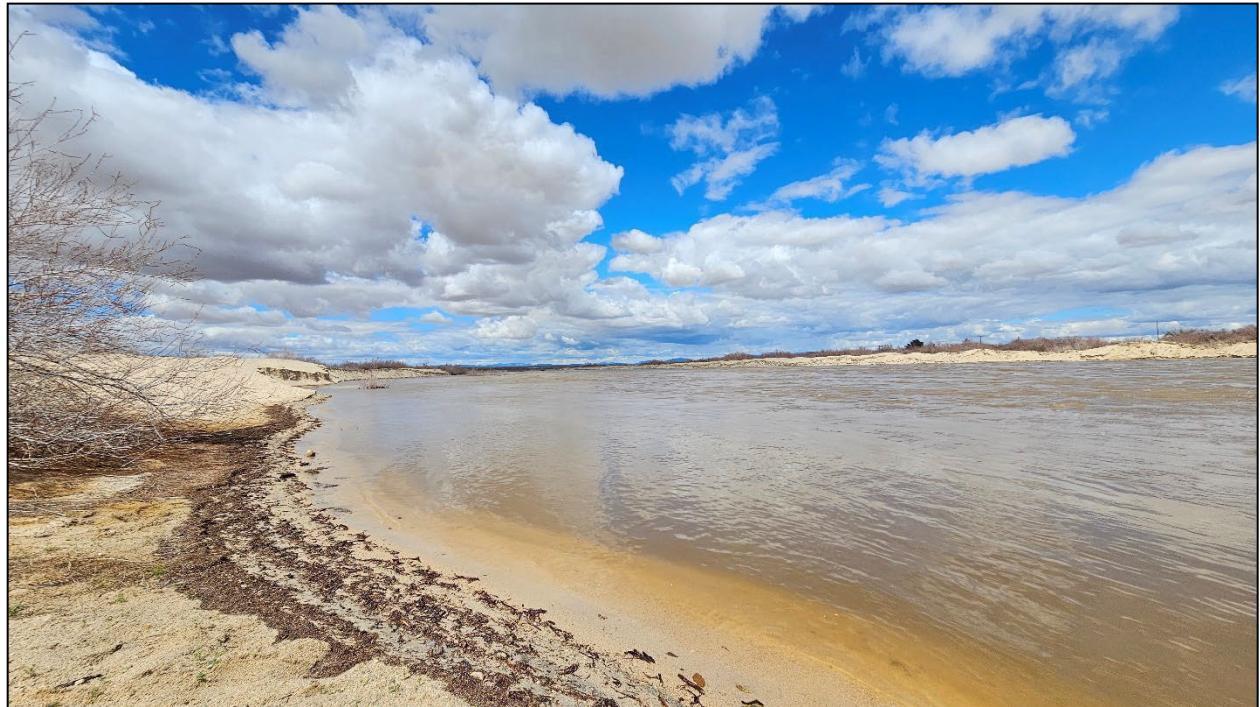
Figure 3.3 - Hinkley Road Bridge on 03/23/2023. USGS <u>Hinkley stream gage</u> discharge measured 1470 cubic feet per second

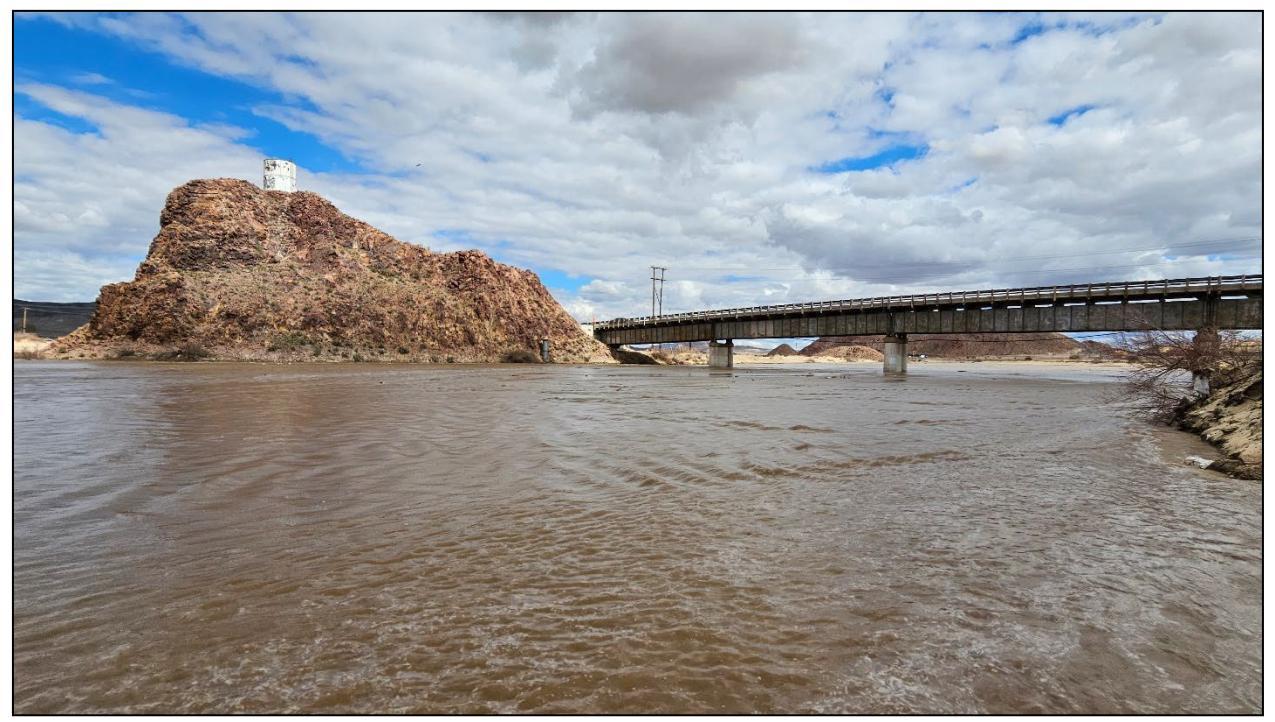
Figure 3.4 - Barstow First Street from west side of the First Street Bridge on 03/23/2023. USGS Barstow stream gage measured discharge 308 cubic feet per second

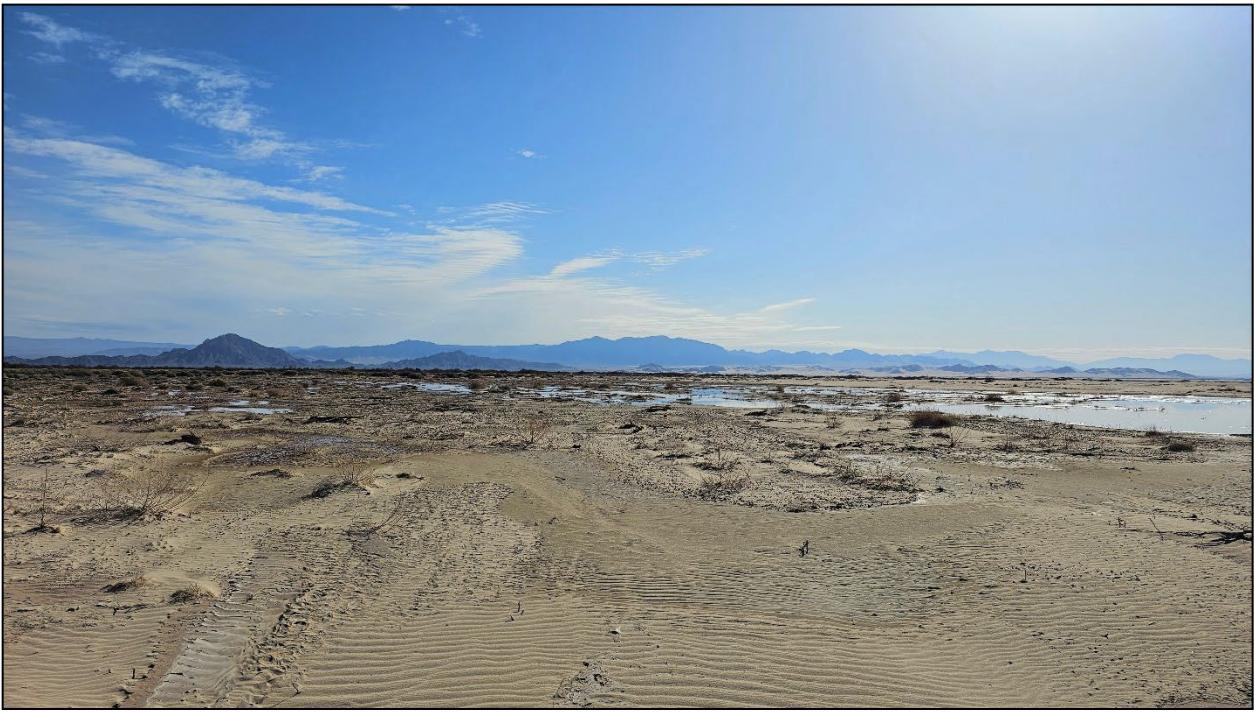
Figure 3.5 - Surface flow at the end of the Mojave River at Soda Dry Lake on 03/25/2023

The Mojave River began flowing at the surface after a series of storms dropped rain and snow across southern California in early 2023. While the Mojave River flows aboveground periodically, it is usually a dry, sandy riverbed in the middle of a parched desert landscape. Surface flow was observed at the Barstow First Street Bridge (Figure 3.1) on March 15, 2023. A few days later and following the passing of another storm system, South Lahontan Basin staff Engineering Geologists Amanda Lopez and Tiara Crucius followed the Mojave River surface flow beginning at the headwaters at the Mojave Forks Dam (Figure 3.2), stopping at Hinkley Road (Figure 3.3), and re-visiting the Barstow First Street Bridge (Figure 3.4) observing significantly more flow at this location compared to what was observed on March 15, 2023. Continuous surface flow was observed through the riverbed out to Afton Canyon, a rare occurrence that last happened in 2010. On March 25, 2023, surface flow was encountered cutting the west boundary of the Mojave National Preserve, having reached Soda Dry Lake (Figure 3.5).

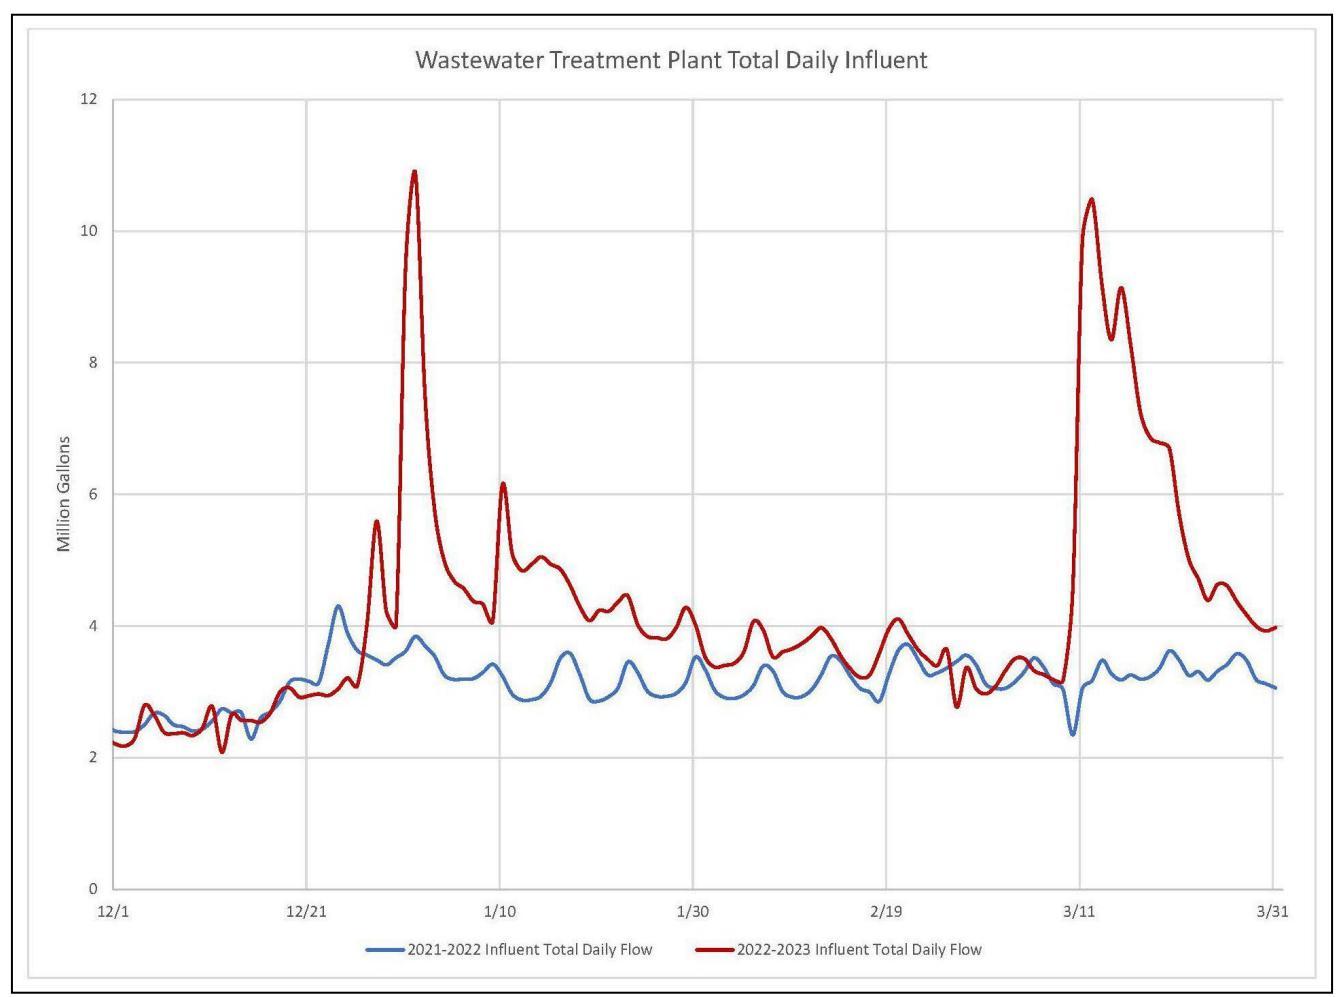
STPUD experienced inflows greater than treatment plan capacity during March 2023. These inflows resulted from stormwater surface flows and saturated soils causing high infiltration and inflow throughout their sewage collection system. Normal sewage flows into the treatment plant are between 3-4 million gallons per day (MGD). STPUD pretreatment system can accommodate high flow rates up to 17 MGD but the treatment system and export line can only handle roughly 8 MGD. The use of emergency retention basins is required when the flows into the treatment plant exceed 8 MGD. In mid-January and early March 2023, the inflows peaked at 11 MGD and had sustained inflows over 8 MGD (Figure 2). The emergency retention basins were used in both storm events and as intended without being overwhelmed.

Figure 4.1 – South Tahoe Public Utility flows into the watste water treatment plant during winter of 2021-2022 and 2022-2023

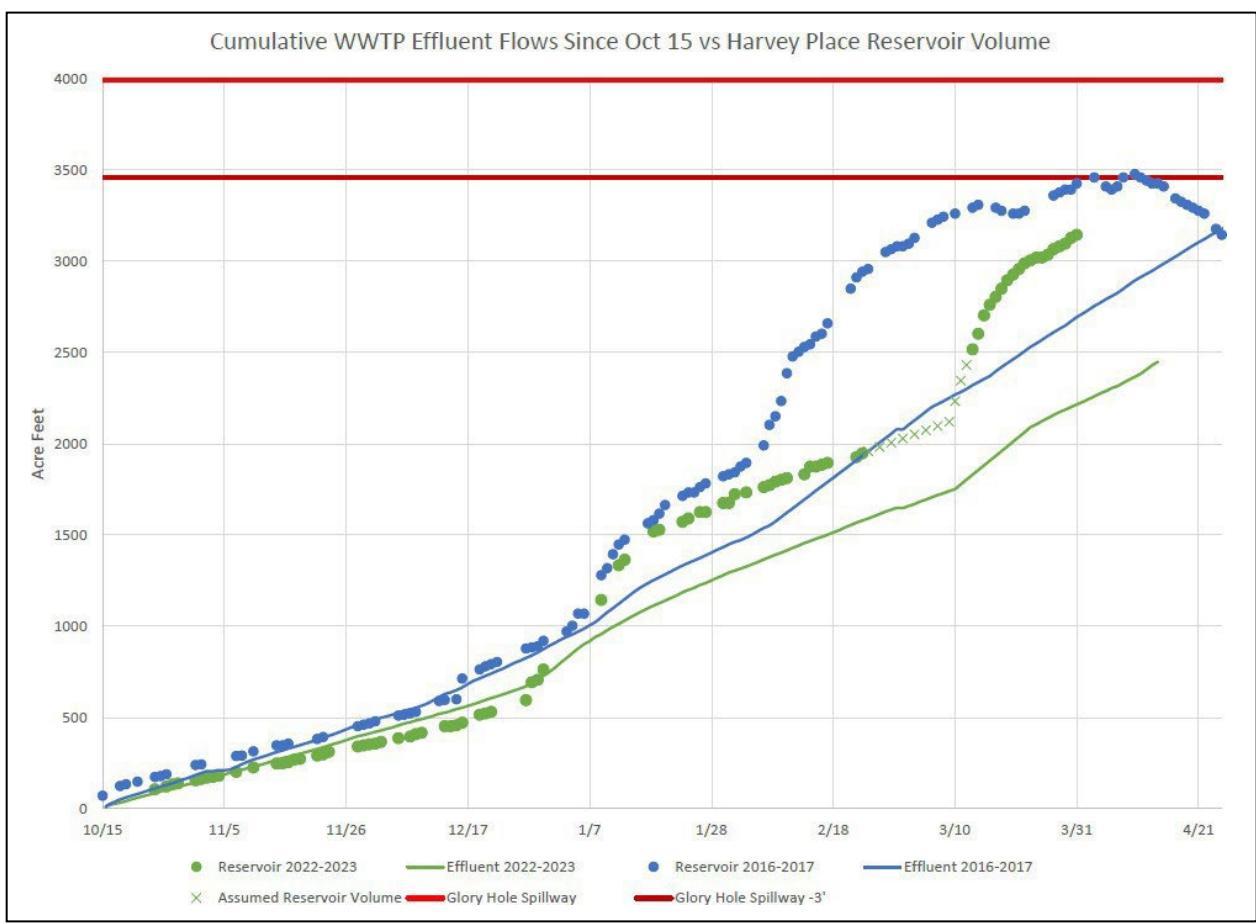
High-water levels occurred at the Harvey Place Reservoir, the discharge location for all STPUD's treated wastewater. The reservoir levels approached the emergency "glory hole" spillway near the end of March 2023, due to export pumps running continuously from the treatment plant. The storms in Alpine County also added significant storm runoff volume into the reservoir (Figure 3). STPUD assessed the risks of overflowing the reservoir into Indian Creek versus the risks of releasing recycled water to the Fredericksburg Ditch before their recycled water permits allowed. STPUD determined weakened dam integrity and overflow due to sustained high volumes flowing into the reservoir was a greater risk than releasing unauthorized recycled water into their iceberm-compromised Diamond Valley Ranch ditch system. A total of 42 acre-feet (13.7 million gallons) was released into the Fredericksburg Ditch over a period of 4 days at 5 cubic feet per second. This release avoided a spill into Indian Creek and provided sufficient freeboard to handle further runoff.

Figure 4.2 – Volume in the Harvey Place Reservoir from 2017 and 2023 compared to the effluent being pumped from the Luther Pass Pump Station indicated the reservoir volumes almost breached the glory hole due to stormwater runoff

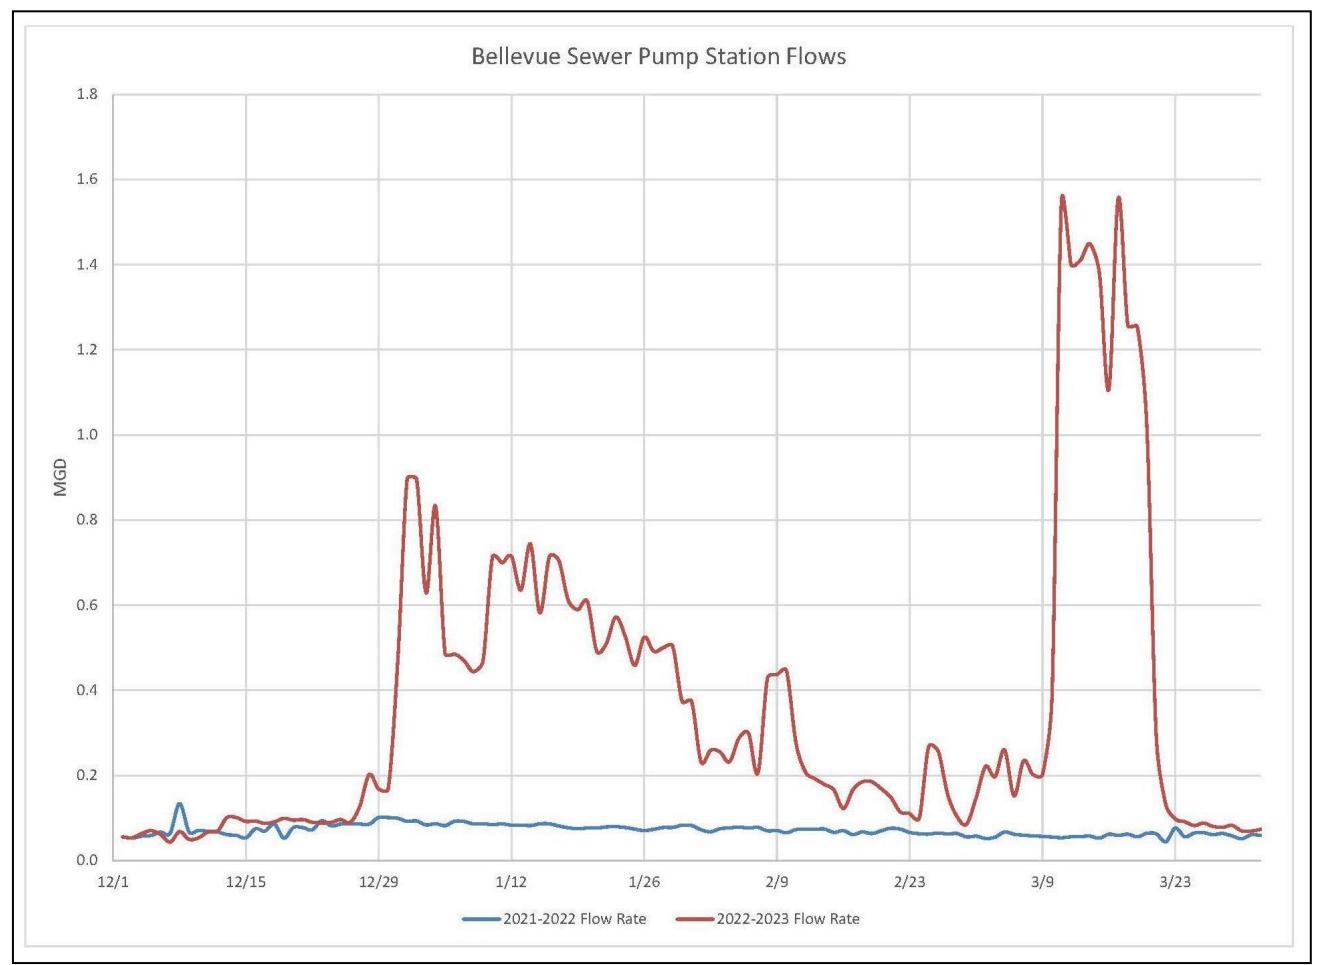
impacted by high volumes of sewage due to the increased volumes of surface water runoff and ground water infiltrating and flowing into the sewer collection system. To keep up with the flows, the Bellevue's two pumps were pumping simultaneously at max capacity increasing the potential of pump burnout and failure. For instance, the 2021-2022 winter flows from the Bellevue were about 100,000 gallons a day but the early March storms with heavy snow resulted in flow rates between 1 and 1.4 million gallons per day, a tenfold increase (Figure 4).

Figure 4.3 – Bellevue Pump Station flows in winter 2021-2022 compared to winter 2022-2023

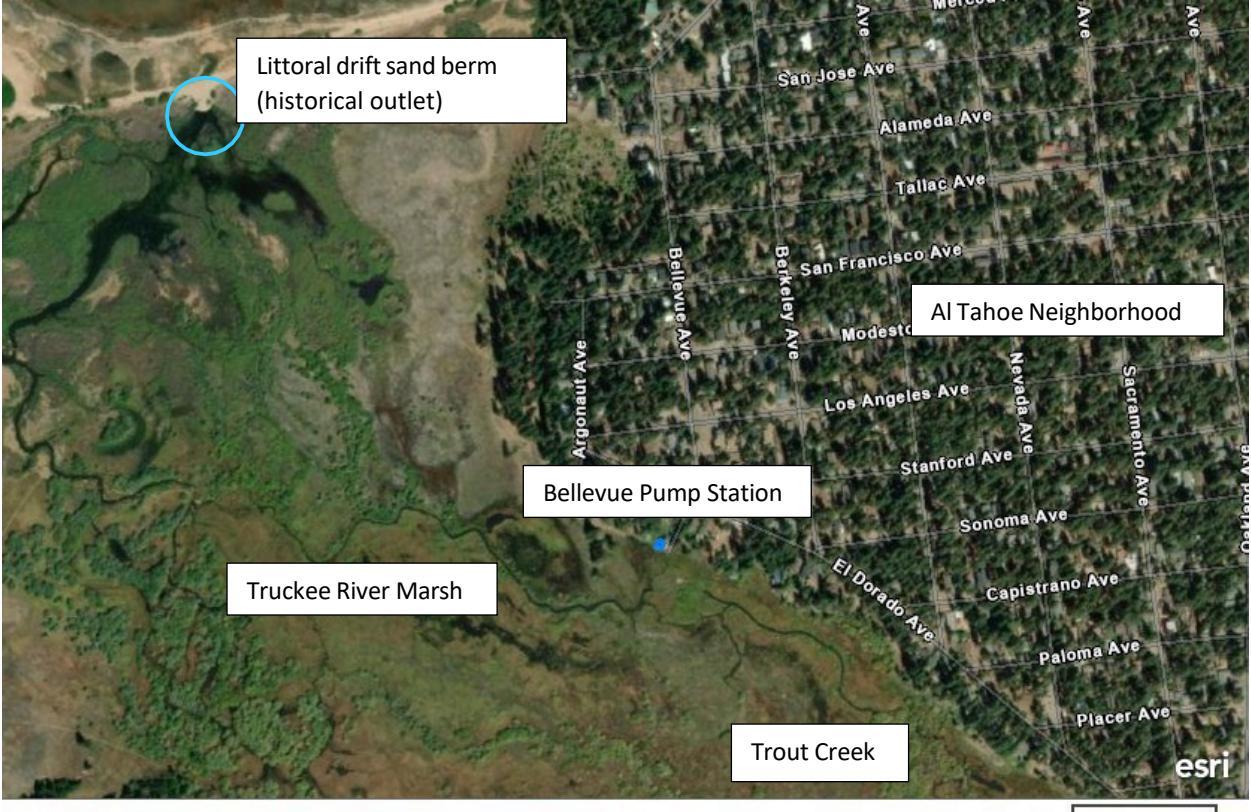
Addressing the sand berm at the historic channel outfall provided immediate relief to Bellevue by reducing the water level in the marsh by more than a foot within 24 hours. Figure 1 shows the relationship between the Upper Truckee Marsh, Trout Creek, Bellevue, the AI Tahoe neighborhood, and the outlet to Lake Tahoe.

Figure 4.4 – Bellevue Pump Station in relation to the Al Tahoe neighborhood and the Upper Truckee River Marsh

- reducing the risk of electrical failure due to flooding by adding sandbags, plywood, and sheet piles outside of Bellevue
- setting up an emergency pump capable of handling more than the maximum flows (1.7 – 2.4 MGD) in case of pump failure
- setting up a bypass pump option and an emergency diversion
- working on breaking up ice dams in the meadow to redirect flow towards the Upper Truckee River
- communicating with the California Tahoe Conservancy, Cal Fire, and Lahontan Water Board staff to breach a littoral drift sand berm blocking a historic outfall channel to Lake Tahoe
- applying for emergency permitting with the Army Corps of Engineers
